Technical Report CHL-97-30  
October 1997

# **Navigation Conditions at Point Marion Lock and Dam, Monongahela River**

## **Hydraulic Model Investigation**

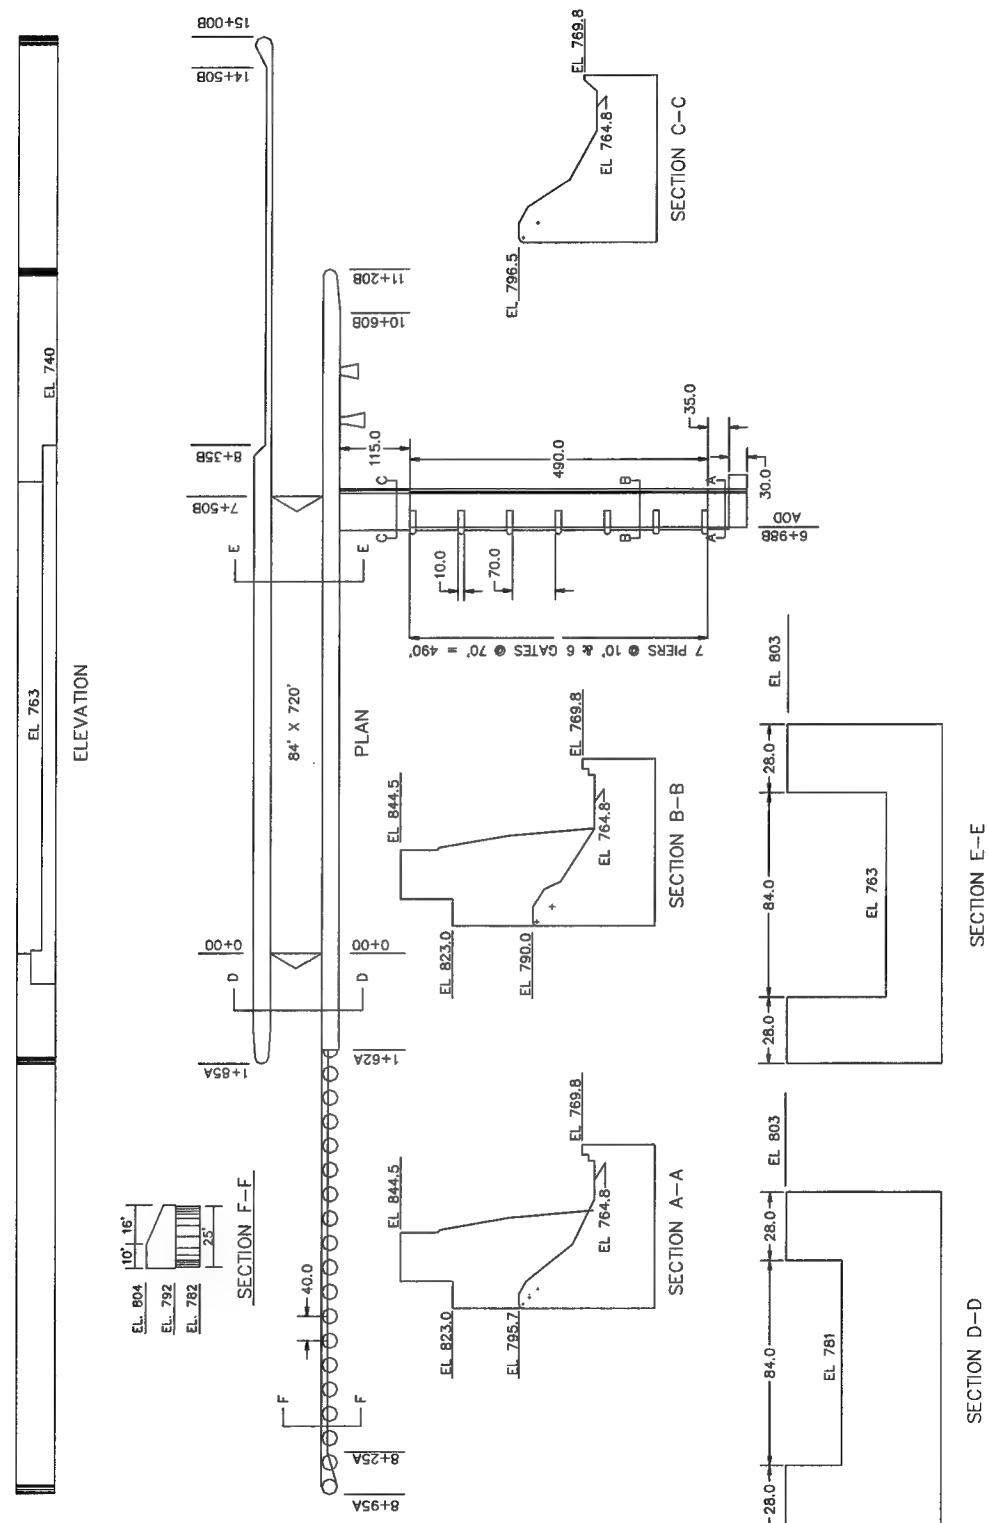
11 Figure 4. Original design, plan and sections

data that could be used to evaluate the effects of proposed modifications on water-surface elevations, current direction and velocities, and navigation conditions. The principal features reproduced or simulated in the model, shown in Figures 3-5, included the following:

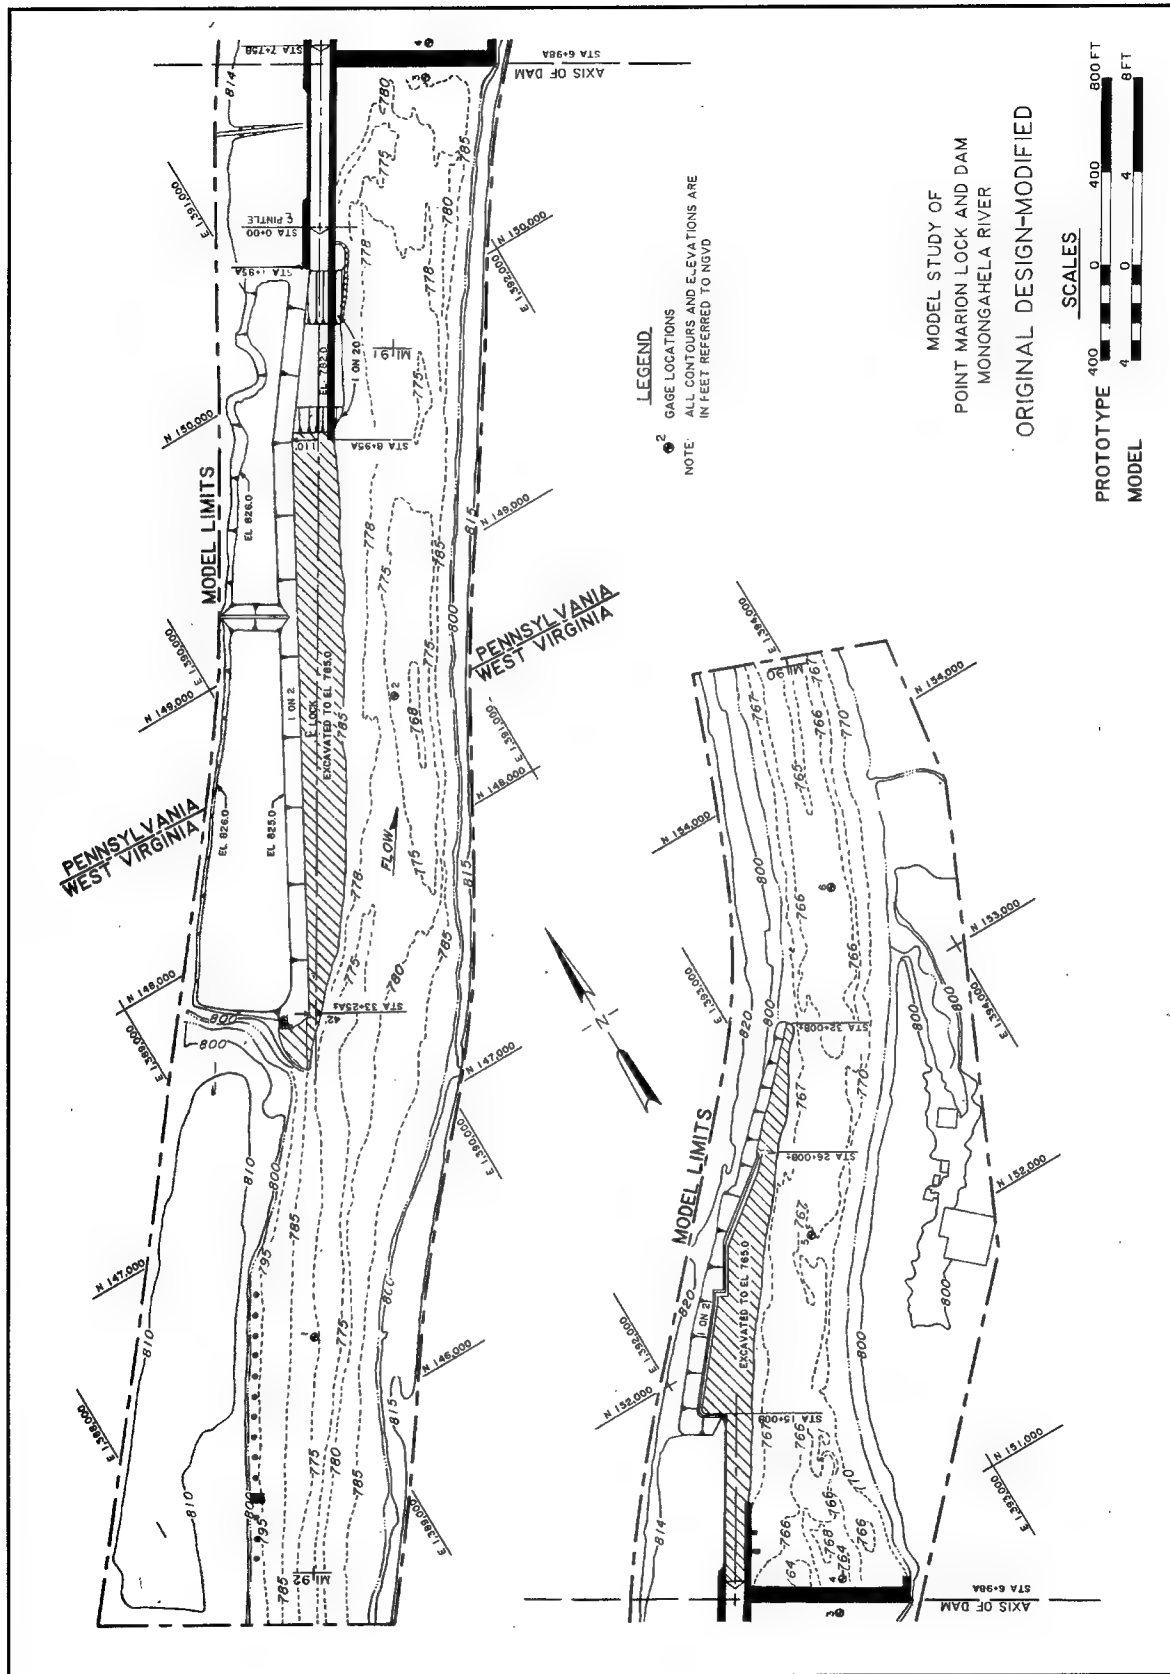
Figure 6. Original Design-Modified

Original Design-Modified (Figure 6) was the same as the original design, except the excavation for the upper approach channel was increased by widening the channel at the upper end of the guard wall to provide a 158-ft-wide channel at navigation depth. The upper approach was excavated along a line extending upstream from the river face of the landside lock wall to a point 142 ft landward of the upstream end of the guard wall and then to a point 42 ft landward of the center line of the lock at sta 33+25A. This provided a slightly wider navigation channel than the original design for the tow to turn into from the main river channel. This plan was an effort to provide satisfactory navigation conditions for downbound tows approaching the lock while minimizing excavation of the left bank.

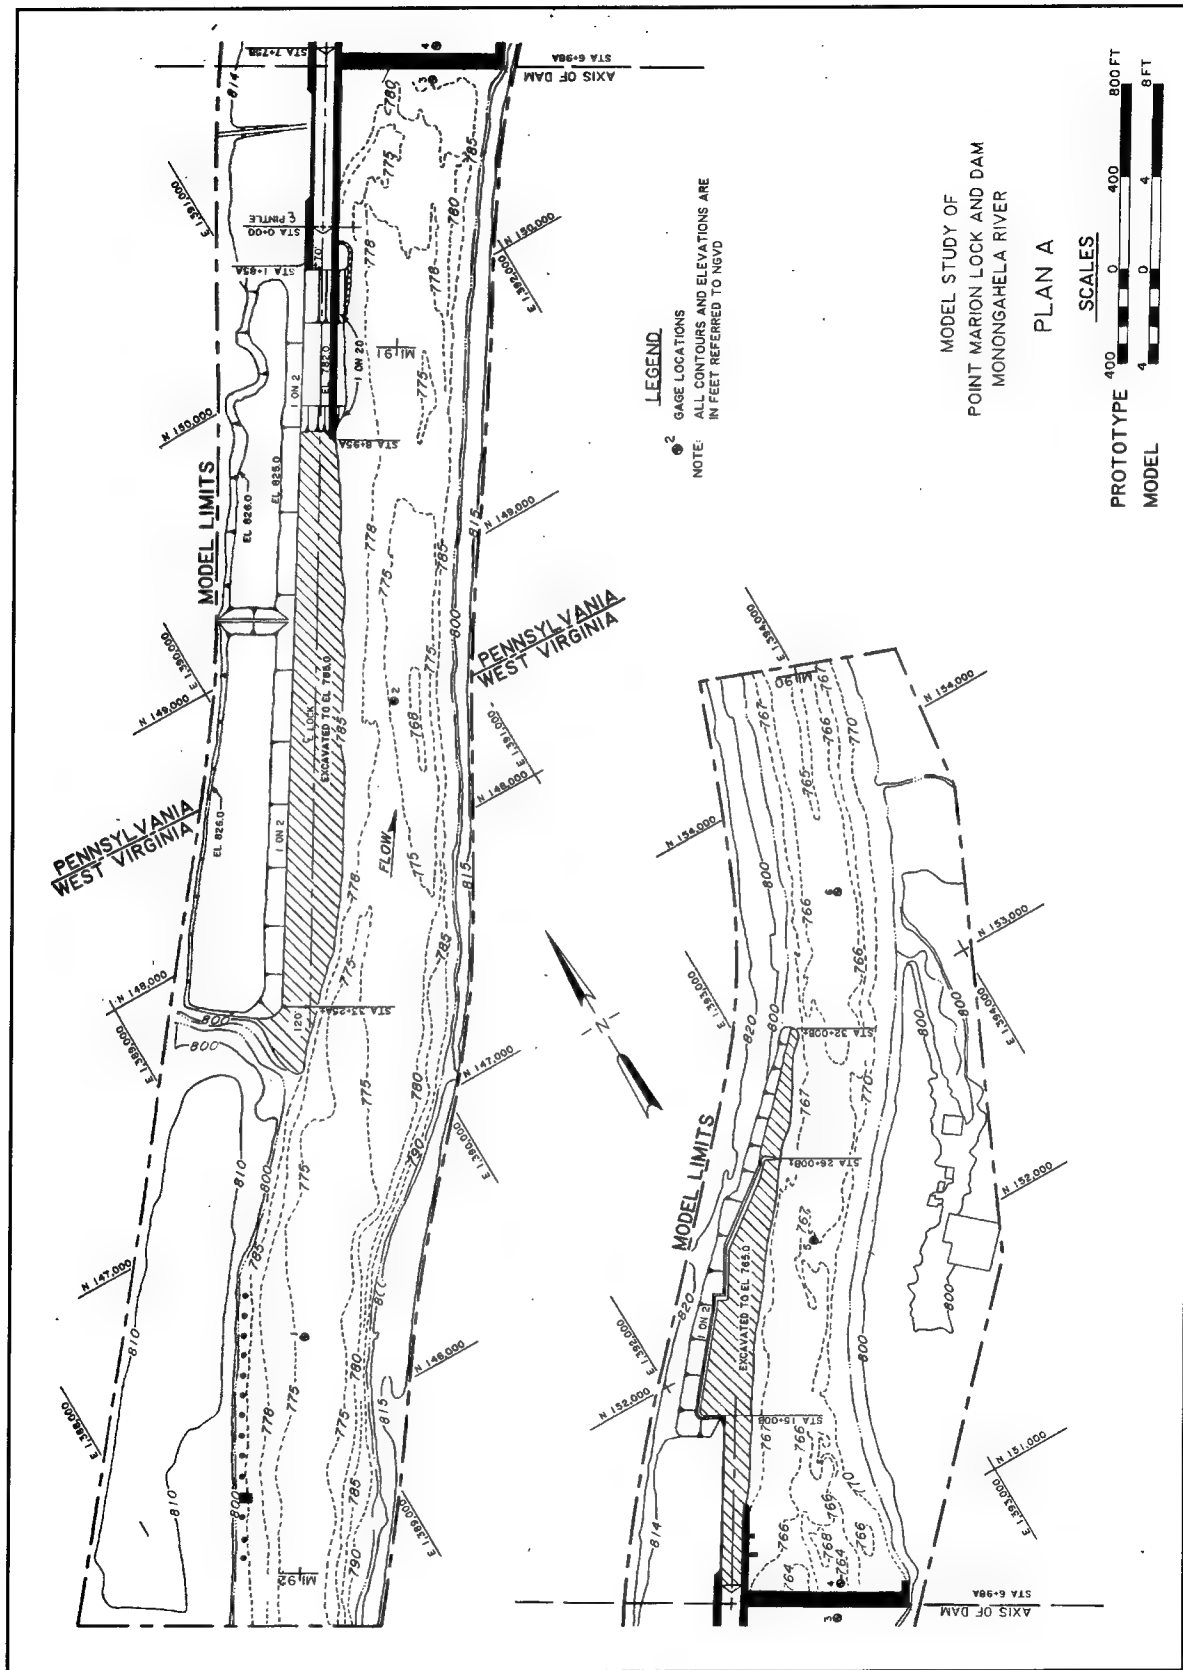
Plan A (Figure 7) is the same as the original design except for the following:

- a.* The model upstream of sta 36+00, in the vicinity of the left bank mooring cells, was remolded to a more recent hydrographic survey provided by the Pittsburgh District. The survey provided navigation depth along the left bank in the vicinity of the mooring cells.
- b.* The left bank excavation was modified to provide additional channel width approaching the upper guard wall. The upper approach was excavated to along a line extended upstream from the land face of the landside lock wall to a point 120 ft landward of the center line of the lock at sta 33+25A. The excavation was then curved landward and tied into Crooked Run Creek, which enters the river immediately upstream of sta 33+25A. This provided a channel about 115 ft wide at the upstream end of the guard wall.

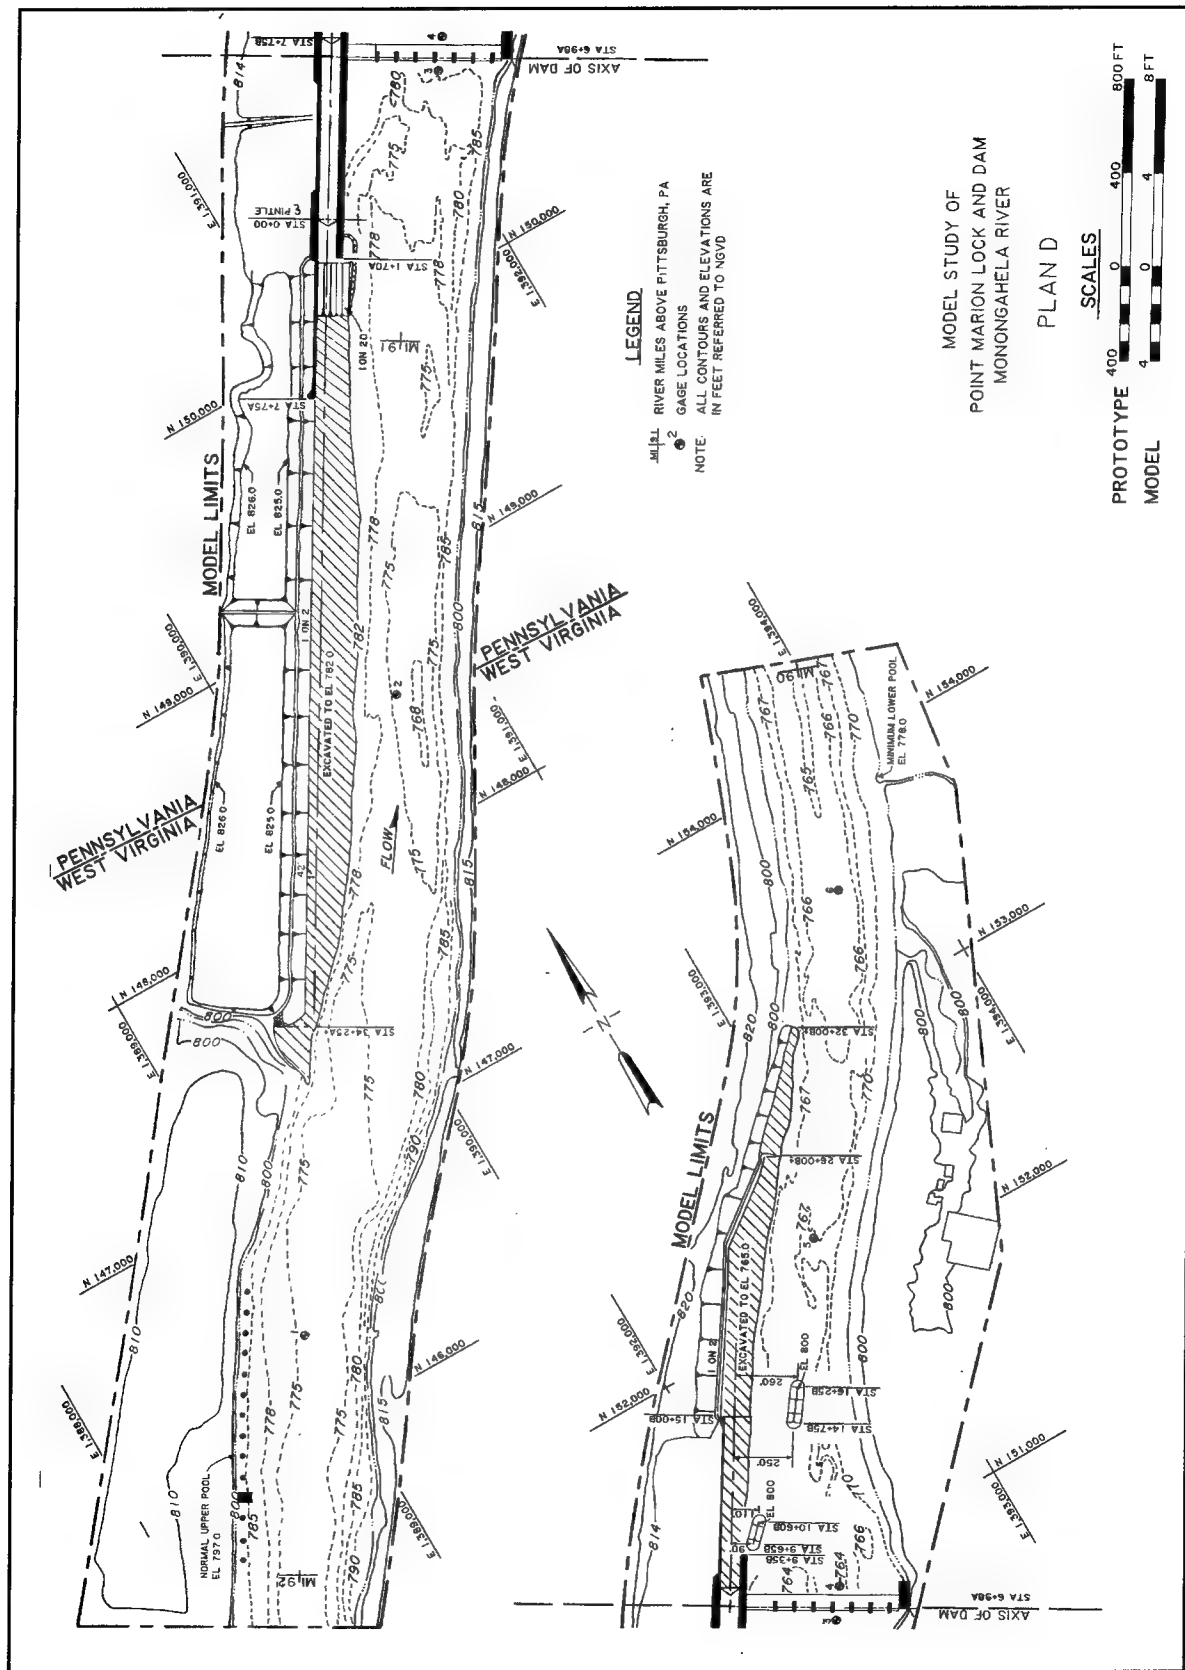
The principal features of Plan D (Figure 11) were as follows:

- a. The lock and dam structures were the same as Plan C except the ported upper guard wall was replaced with a 600-ft-long landside guide wall.
- b. The left bank excavation was modified to provide a navigation channel to the landside guide wall. The upper approach channel was excavated to el 782.0 along a line extending upstream from the river face of the landside guide wall. The left bank was cut to a 1V on 2H slope with the toe of the slope 42 ft landward of the center line of the lock.
- c. The two spur dikes along the right descending bank were removed
- d. The area downstream of the dam was the same as Plan B-Modified.

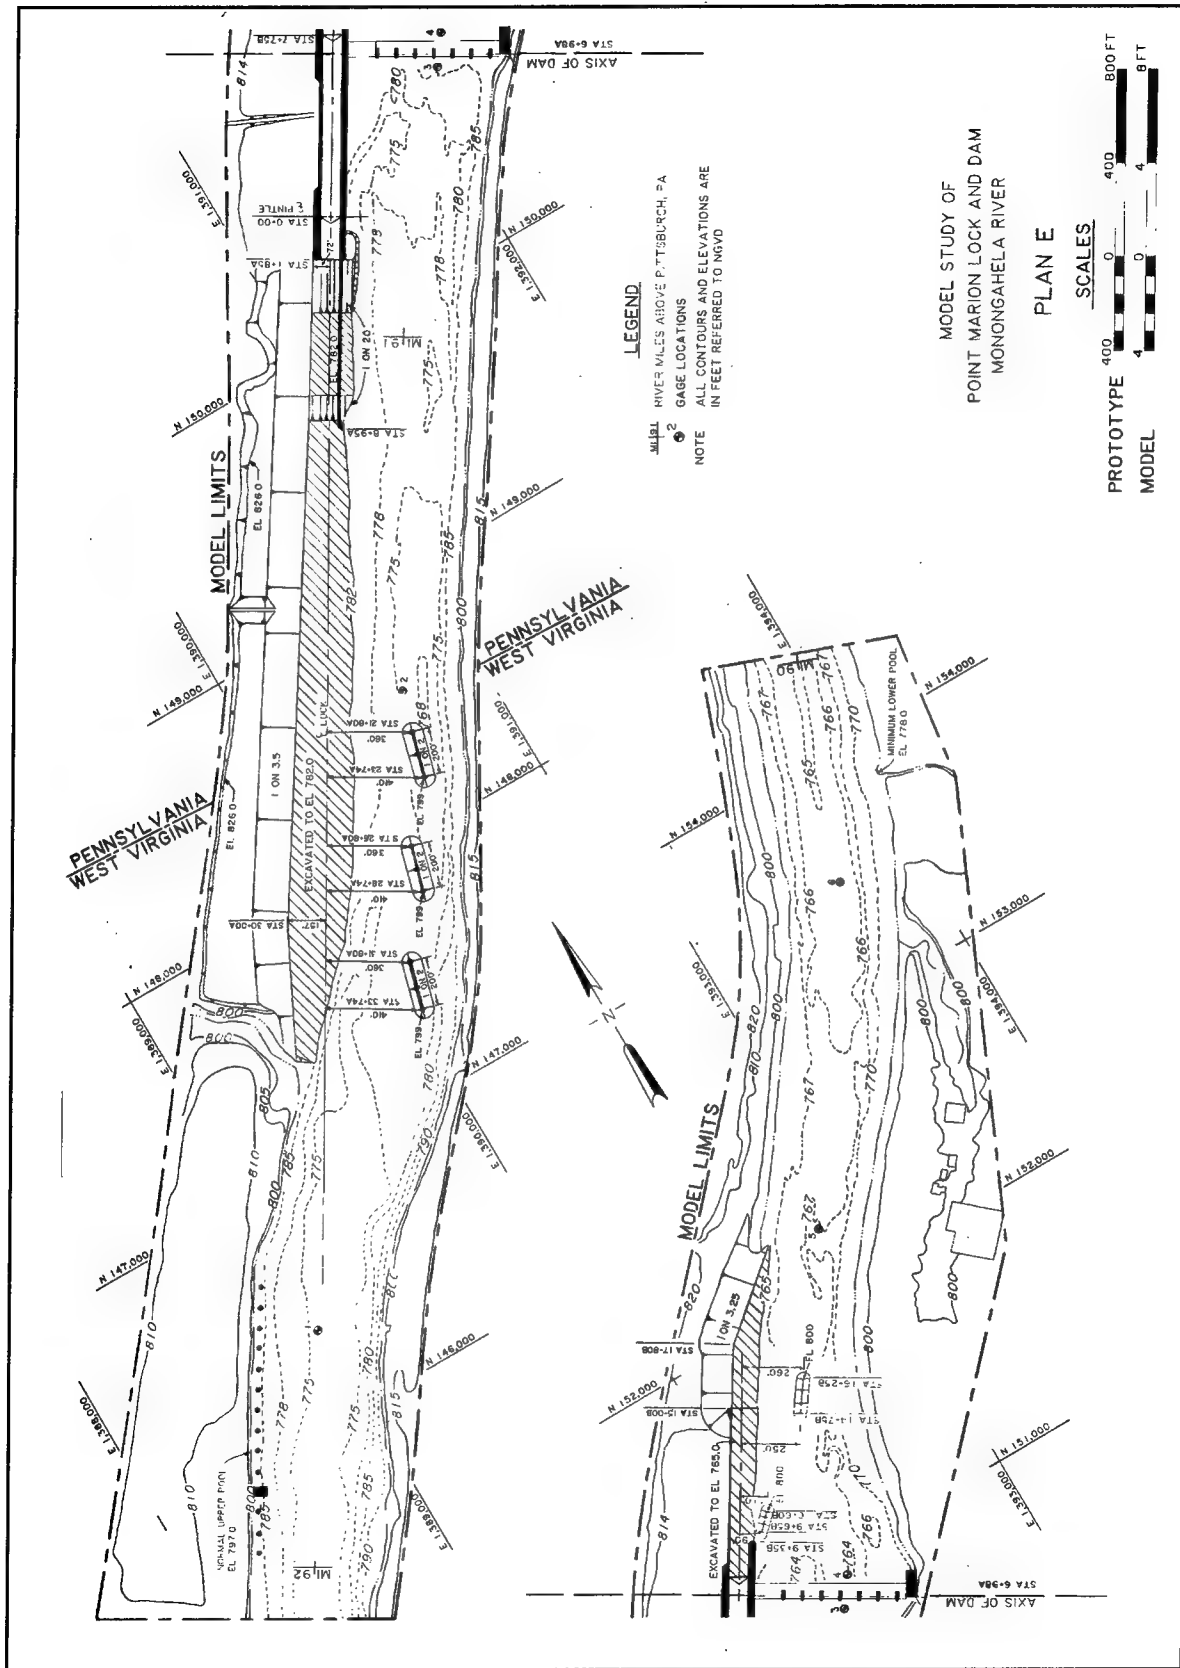
Figure 13. Plan E

The principal features of Plan E (Figure 13) were similar to Plan B upstream of the dam and Plan B-Modified downstream of the dam. The principal features of Plan E were as follows:

- a. A 490-ft nonnavigable gated spillway including six 70- by 8.5-ft tainter gates and seven 10-ft-wide piers. The dam was connected to the right bank by a 35-ft-long fixed-crest weir with a crest el of 795.7 and a 30-ft-long abutment with top el 805.0.

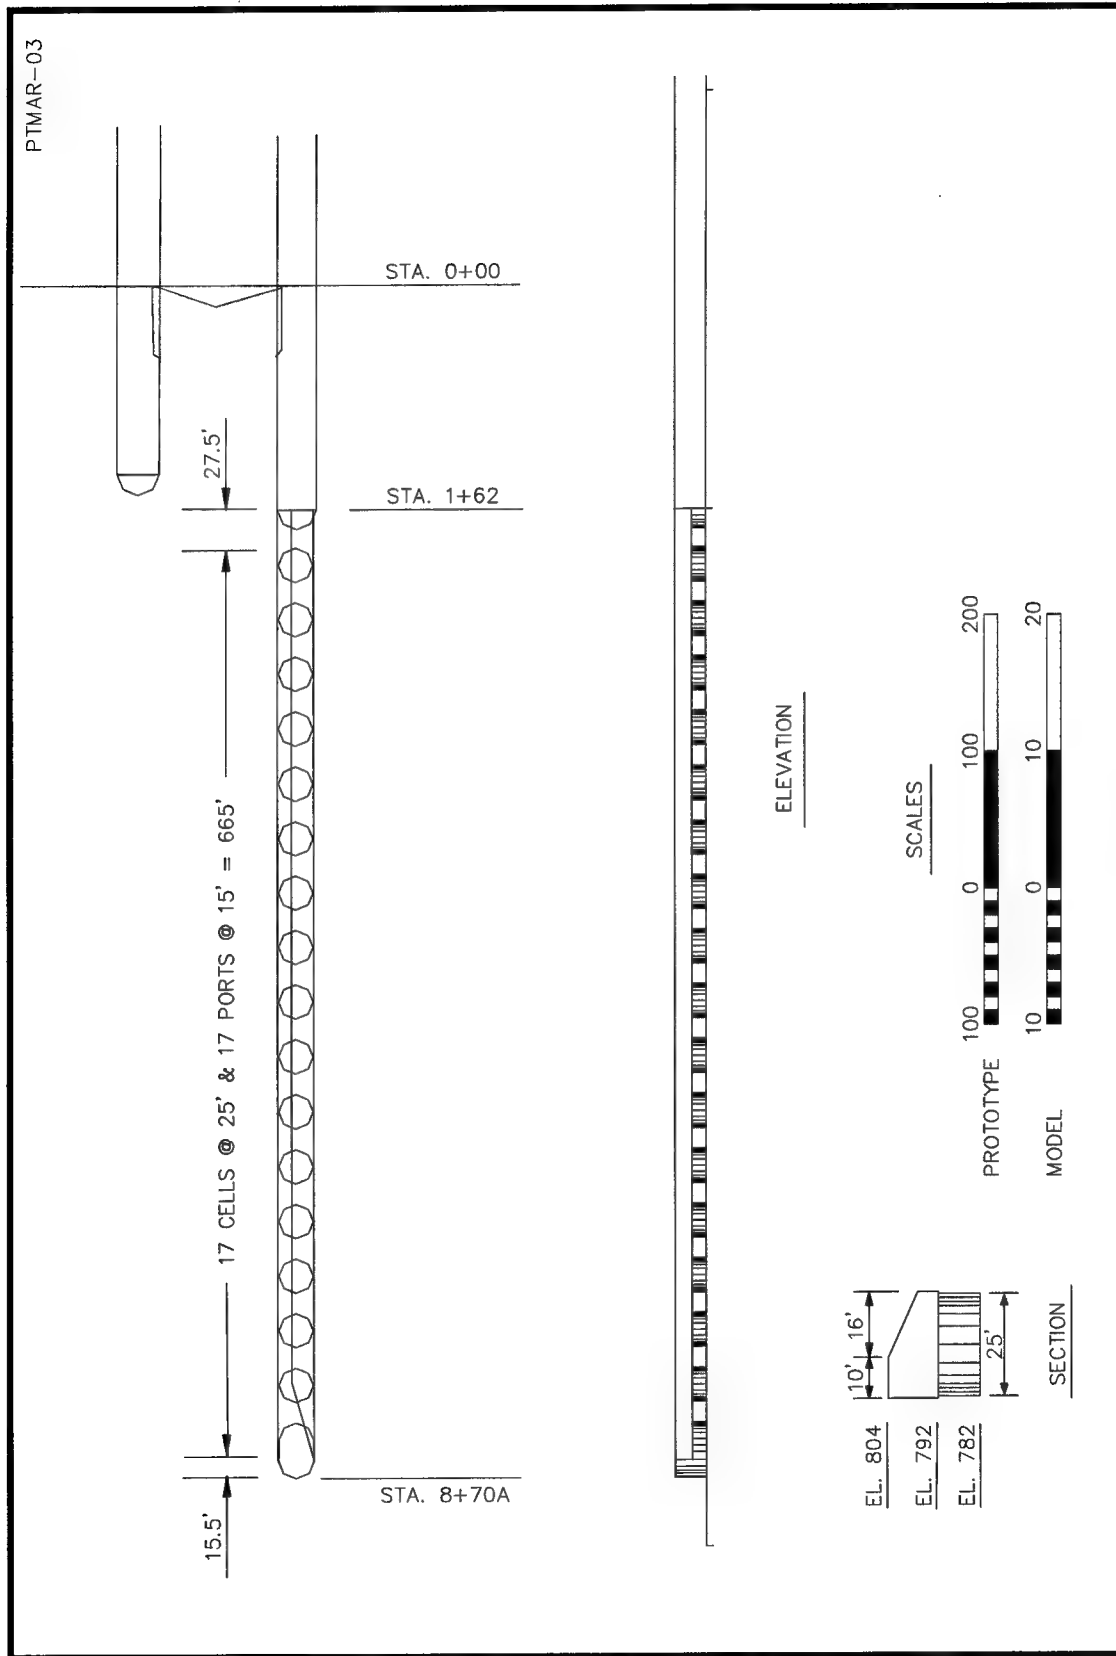
Figure 15. Plan E-Modified guard wall

- a. The left bank slope, both upstream and downstream of the lock, was changed from 1V on 3.5H and 1V on 3.25H, respectively, to 1V on 3H.
- b. The upper guard wall of the new lock was shortened 25 ft from sta 8+95A to sta 8+70A. The cell spacing remained the same as with Plan E. However, this eliminated one port opening. The new design of the guard wall provided seventeen 15-ft-wide port openings with top of ports at el 792.0 (Figure 15).

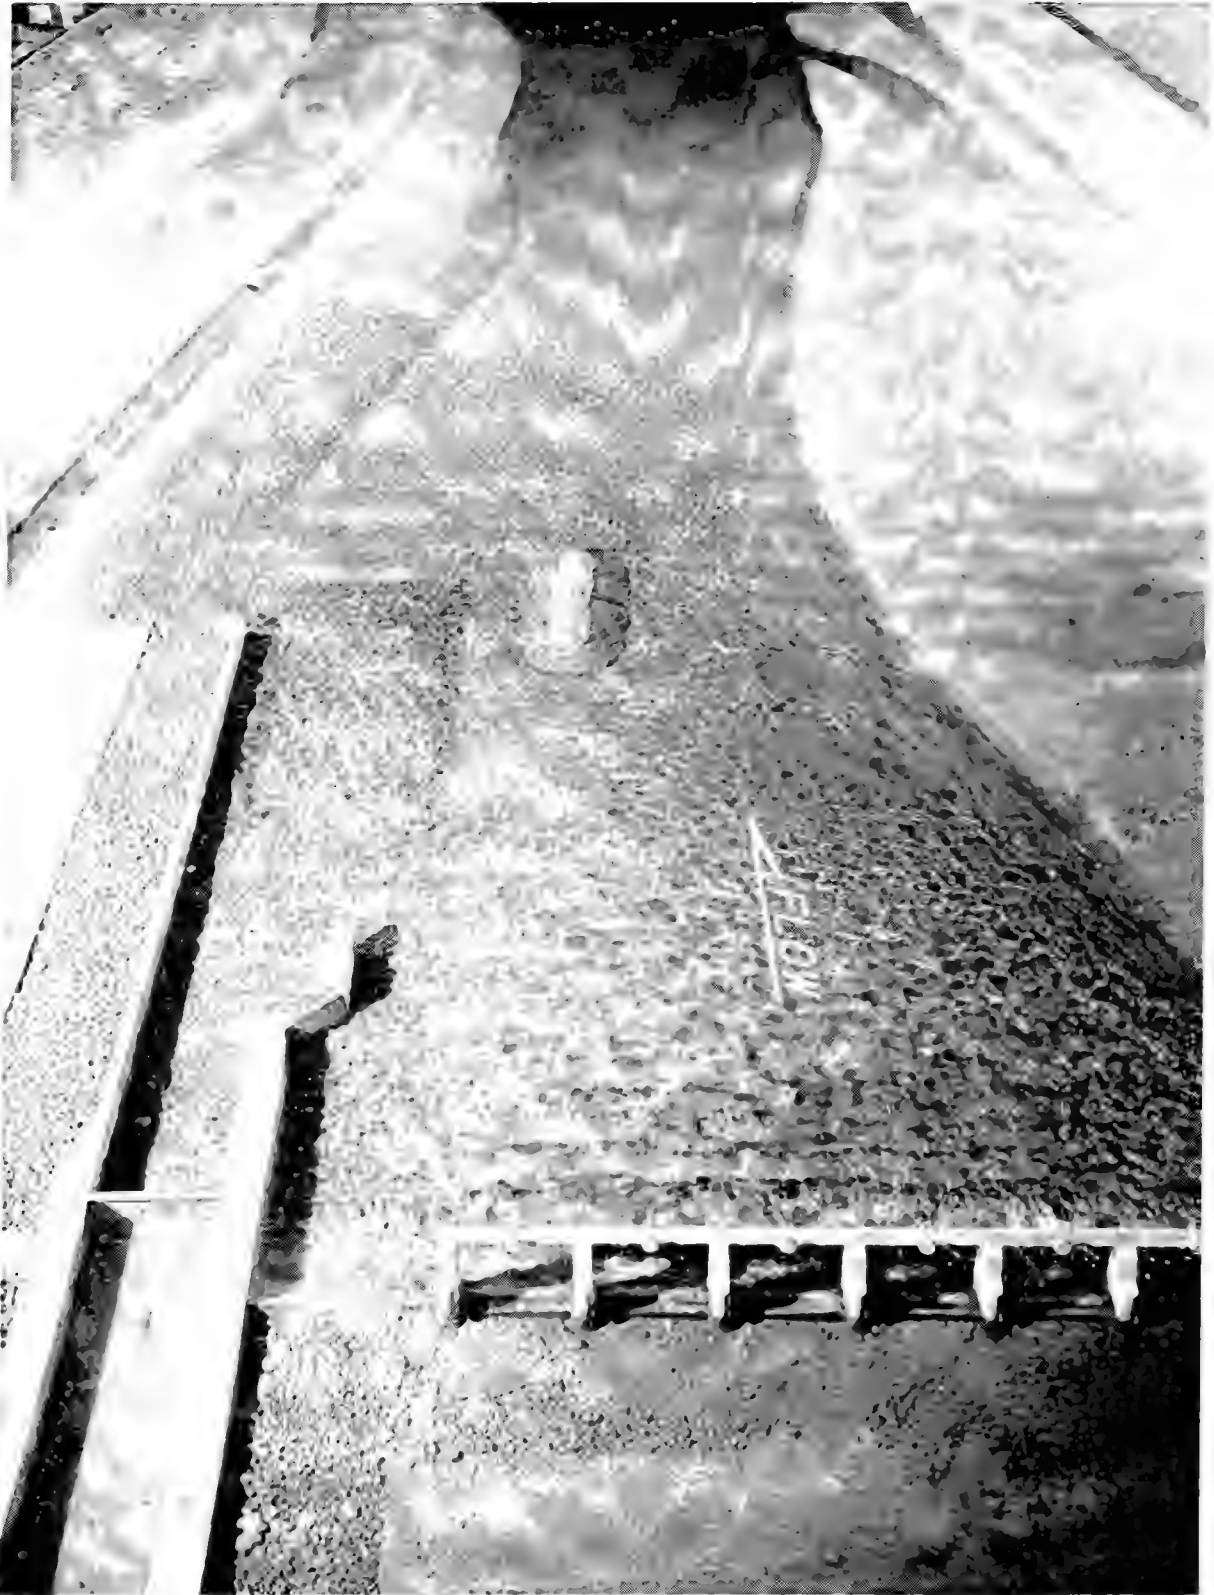
Figure 16. Vane dike

- c. The limits of the excavation in the lower approach to the new lock were changed slightly to conform to more recent information.
- d. The vane dike immediately downstream of the riverside wall of the new lock was replaced by leaving a portion of the existing lock in place and connecting it to the riverside wall of the new lock (Figure 16). This provided a wing wall to control flow moving into the lower lock approach. The downstream end of the wall was at sta 10+35B, and the

top of the wall was at el 803.0, the same as the top of the lock. The wall was parallel to and 50 ft riverward of the center line of the lock from its downstream end to sta 9+35B and then it angled into the downstream end of the riverside lock wall.

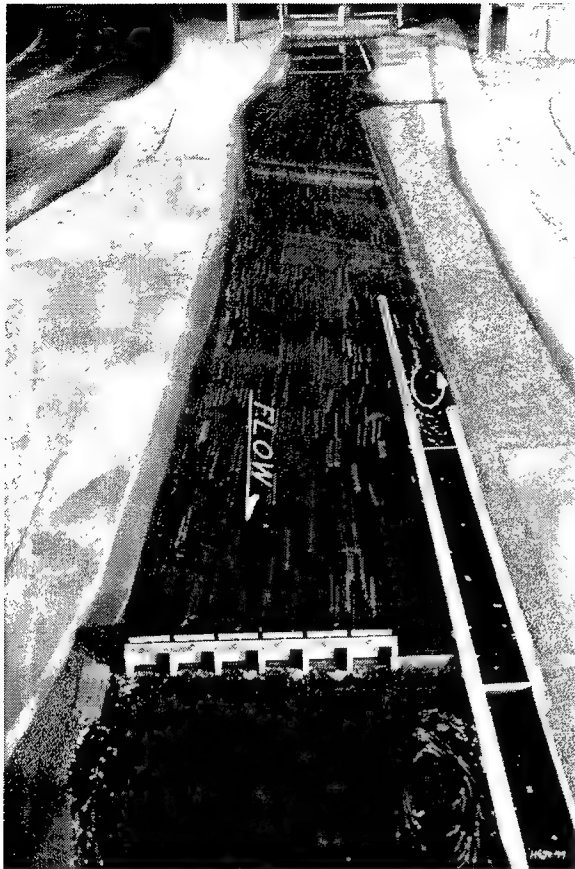
Photo 1. Original design, looking upstream, discharge 55,000 cfs, confetti showing surface current pattern in the upper approach to the lock

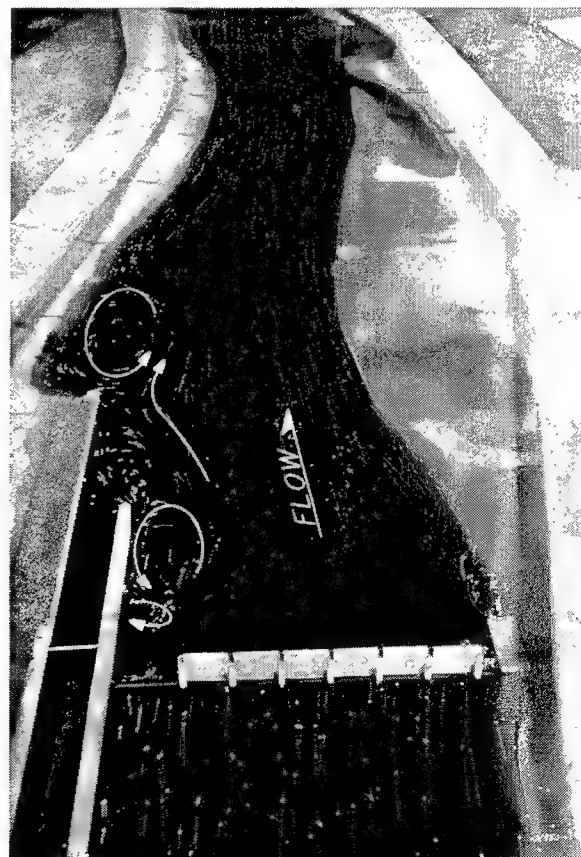
Photo 2. Original design, looking downstream, discharge 55,000 cfs, confetti showing surface current pattern in the lower approach to the lock

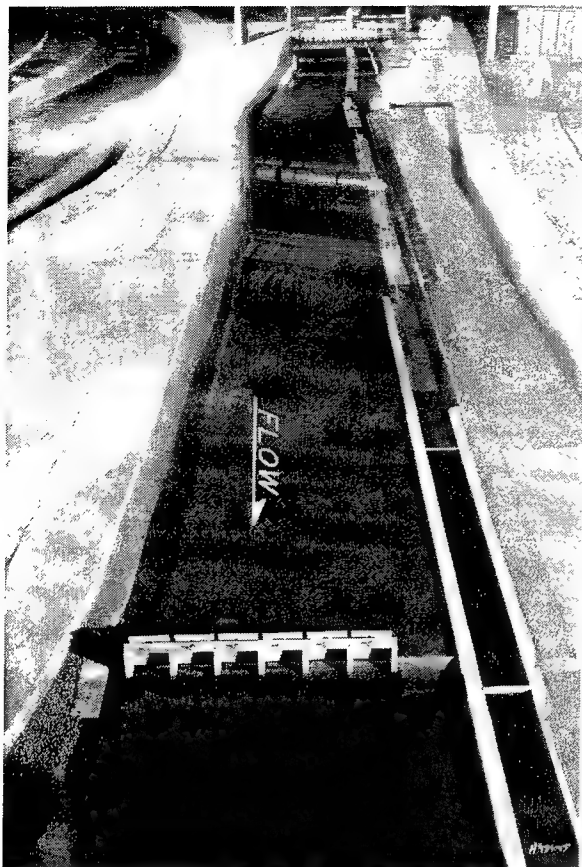
Photo 3. Original design, looking upstream, discharge 55,000 cfs, showing path of down-bound tow approaching lock along left bank and entering lock approach

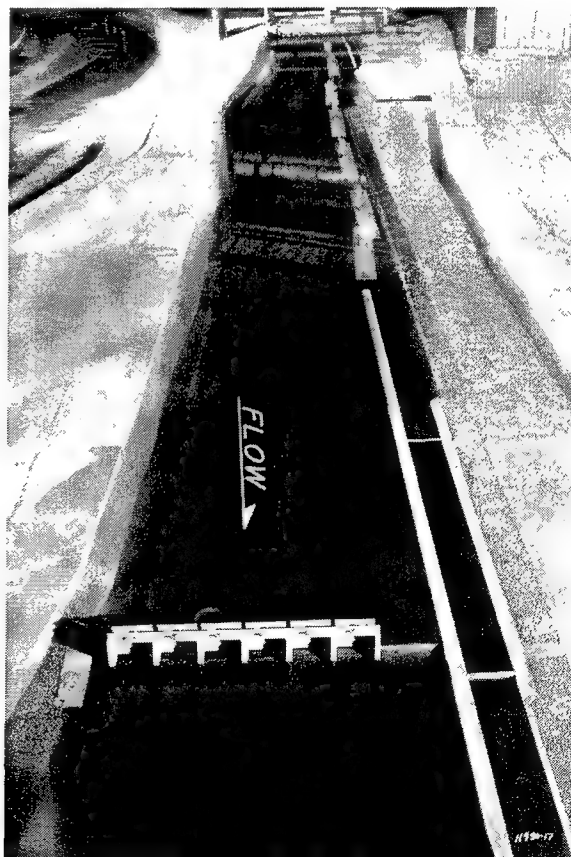
Photo 4. Original design, looking upstream, discharge 55,000 cfs, showing path of down-bound tow approaching lock along left bank and being moved riverward of upper guard wall

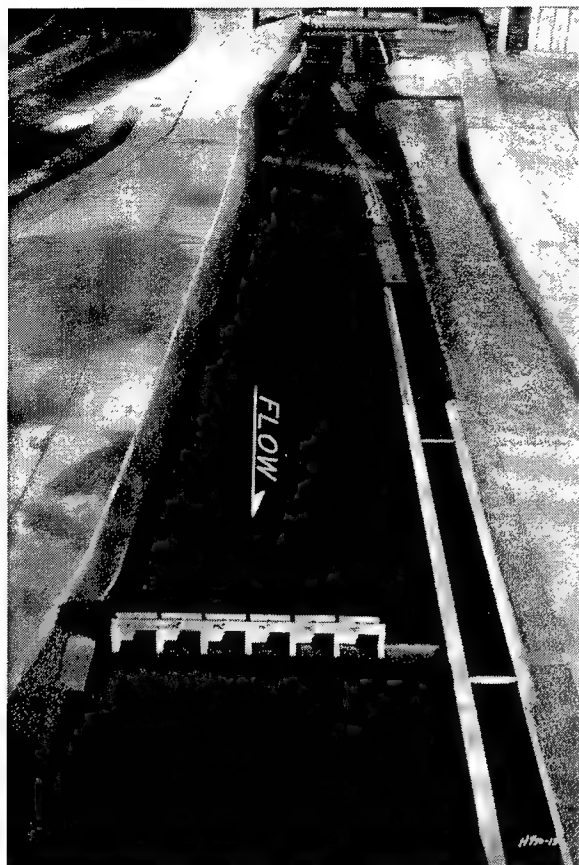
Photo 5. Original design, looking upstream, discharge 55,000 cfs, showing path of tow approaching lock from midchannel

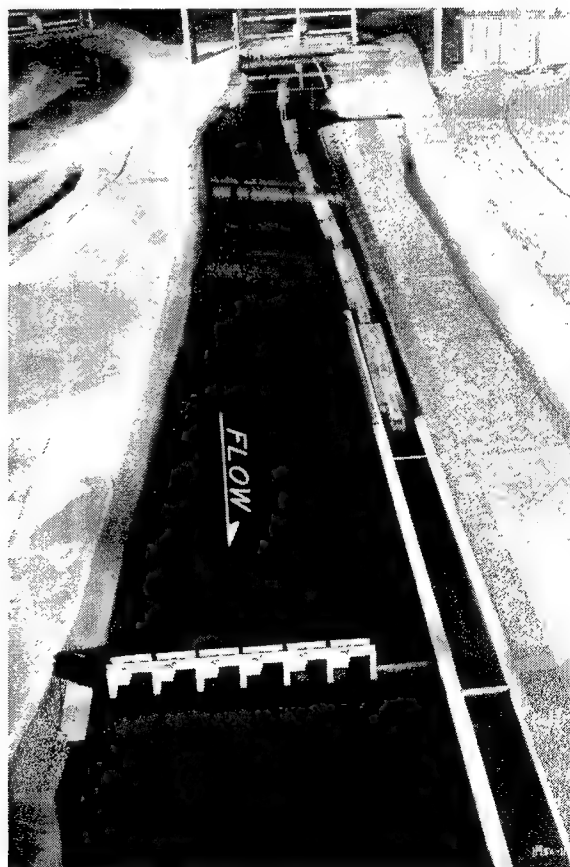
Photo 6. Original design, looking upstream, discharge 55,000 cfs, showing path of upbound tow leaving lock

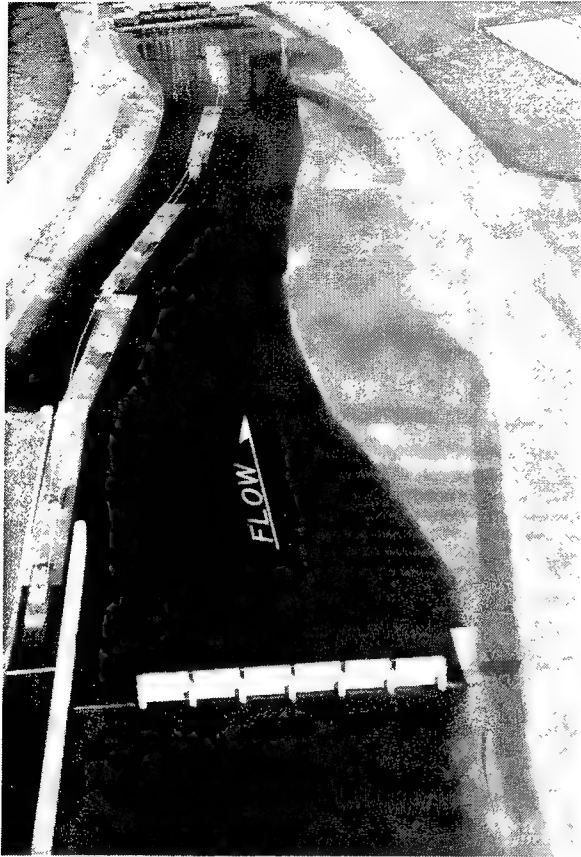
Photo 7. Original design, looking downstream, discharge 55,000 cfs, showing path of down-bound tow leaving lock

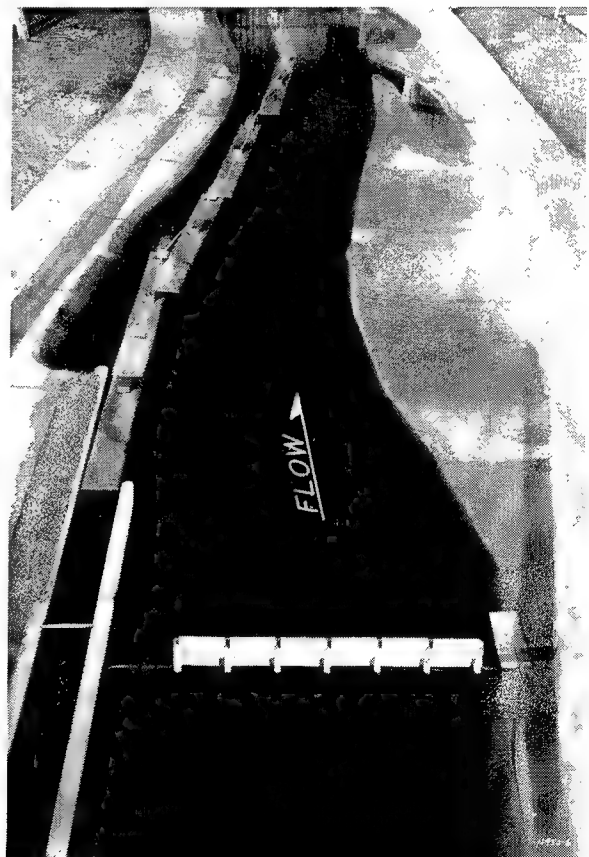
Photo 8. Original design, looking downstream, discharge 55,000 cfs, showing path of upbound tow approaching lock

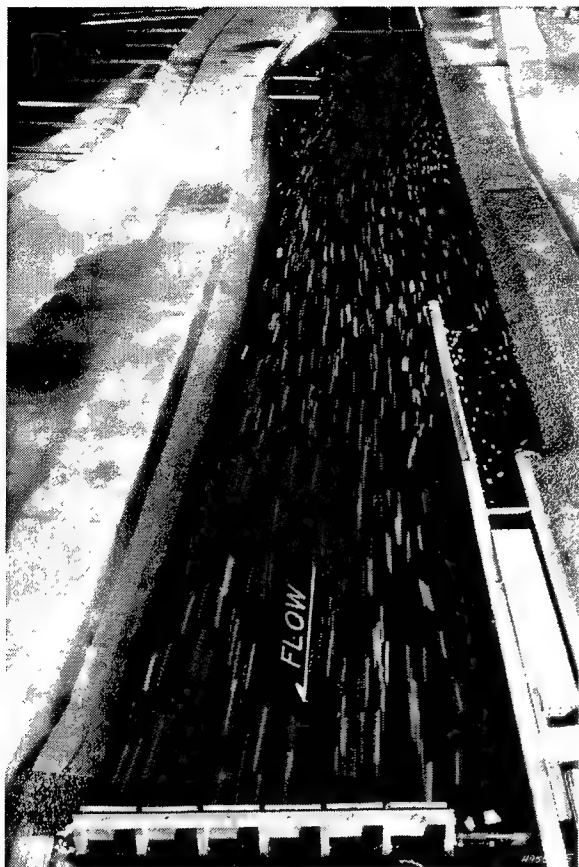
Photo 9. Plan B, looking upstream, discharge 22,500 cfs, confetti showing surface current patterns in the upper approach to the lock

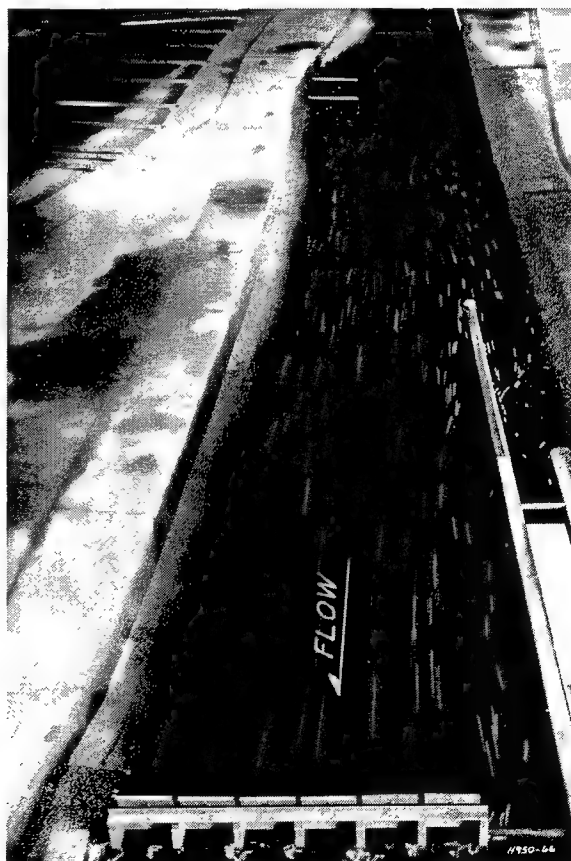
Photo 10. Plan B, looking upstream, discharge 33,000 cfs, confetti showing surface current patterns in the upper approach to the lock

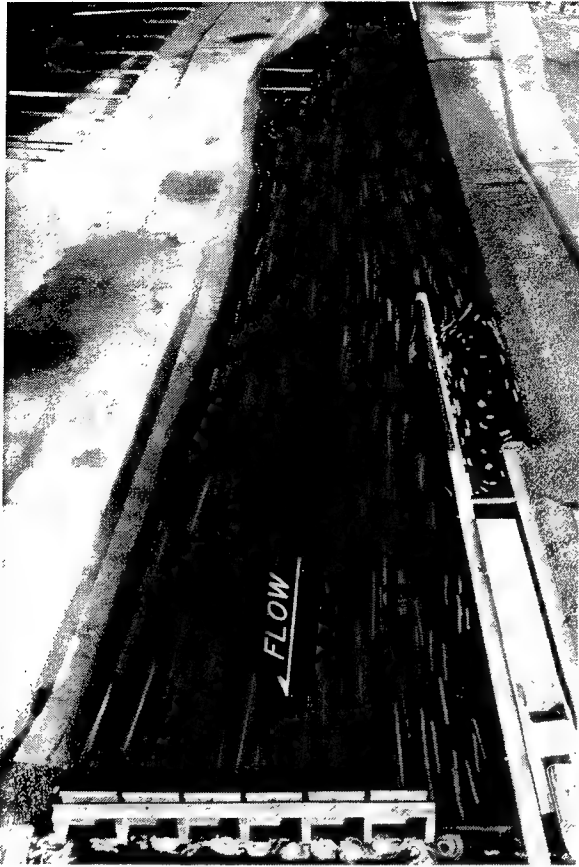
Photo 11. Plan B, looking upstream, discharge 55,000 cfs, confetti showing surface current patterns in the upper approach to the lock

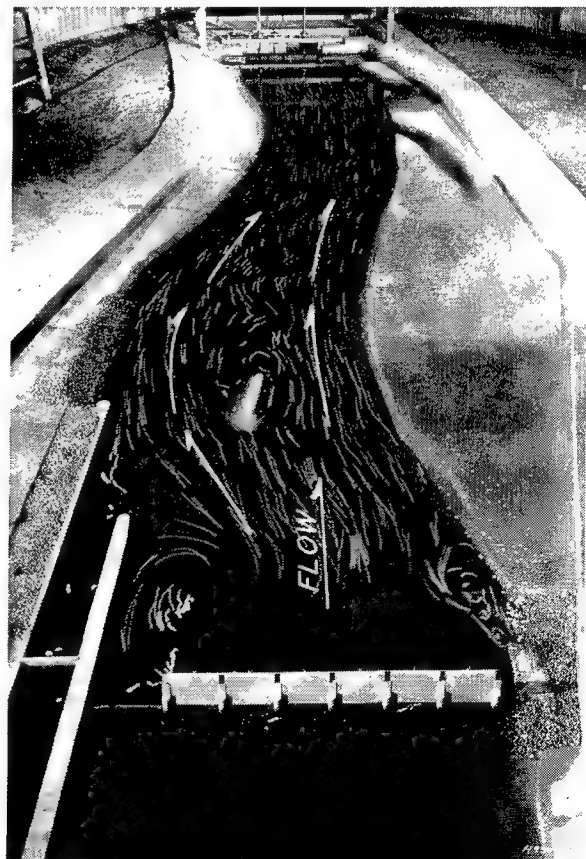
Photo 12. Plan B, looking downstream, discharge 22,500 cfs, confetti showing surface current pattern in the lower lock approach

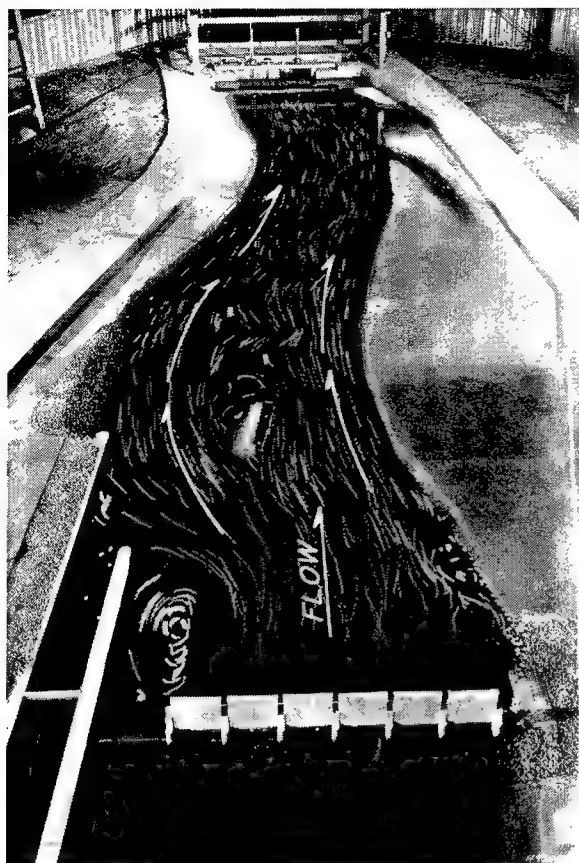
Photo 13. Plan B, looking downstream, discharge 33,000 cfs, confetti showing surface current pattern in the lower lock approach

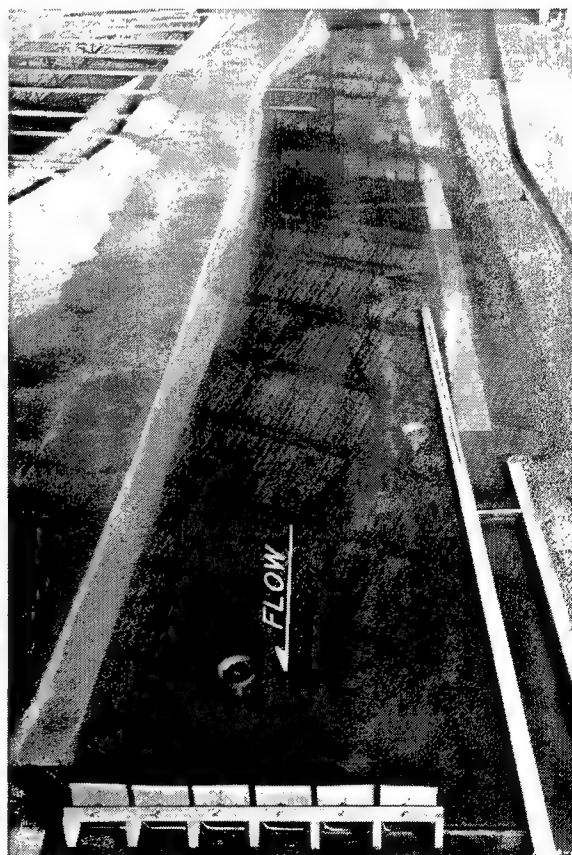
Photo 14. Plan B, looking upstream, discharge 55,000 cfs, showing path of downbound tow approaching lock along left bank

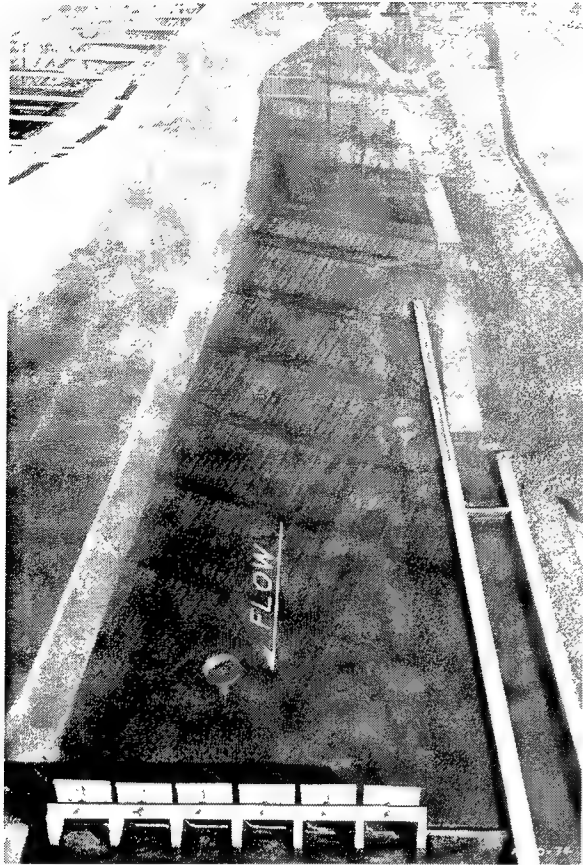
Photo 15. Plan B, looking upstream, discharge 55,000 cfs, showing path of downbound tow approaching lock from midchannel

(Photo 15). The tow could make a slow approach to the guard wall without any tendency for the tow to be moved out of the approach or for the head of the tow to move into the wall with excessive force. No difficulties were indicated for upbound tows leaving the lock. An upbound tow could move away from the guard wall and navigate upstream along the left bank (Photo 16) or move out into the main channel without any difficulties. Because the currents were moving across the lower lock approach, a downbound tow was required to rotate the head of the tow away from the guide wall about 15 deg before leaving the lower approach. After rotating the head of the tow off the guide wall, the tow could drive away from the lower approach and enter the main channel without any difficulties (Photos 17 and 18). Maneuvering the head of the tow away from the guide wall required additional time but was not a difficult maneuver. If the tow moved downstream without maneuvering the head of the tow off the wall, the clearance between the tow and the left bank was minimal for the tow to turn toward the main river channel, and the stern of the tow could ground on the left bank (Photo 19). Upbound tows could leave the main river channel and approach the lower guide wall without any major difficulties (Photos 20 and 21).
